**GEOTECHNICAL EVALUATION
FLORENCE PAVEMENT REHABILITATION
FLORENCE HEIGHTS,
FLORENCE GARDENS PHASE 3 AND 4, AND
HUNT HIGHWAY
TOWN OF FLORENCE, ARIZONA**

January 18, 2017
Project No. 605256001

Subject: Geotechnical Evaluation
Florence Pavement Rehabilitation
Florence Heights, Florence Gardens Phase 3 and 4, and Hunt Highway
Town of Florence, Arizona

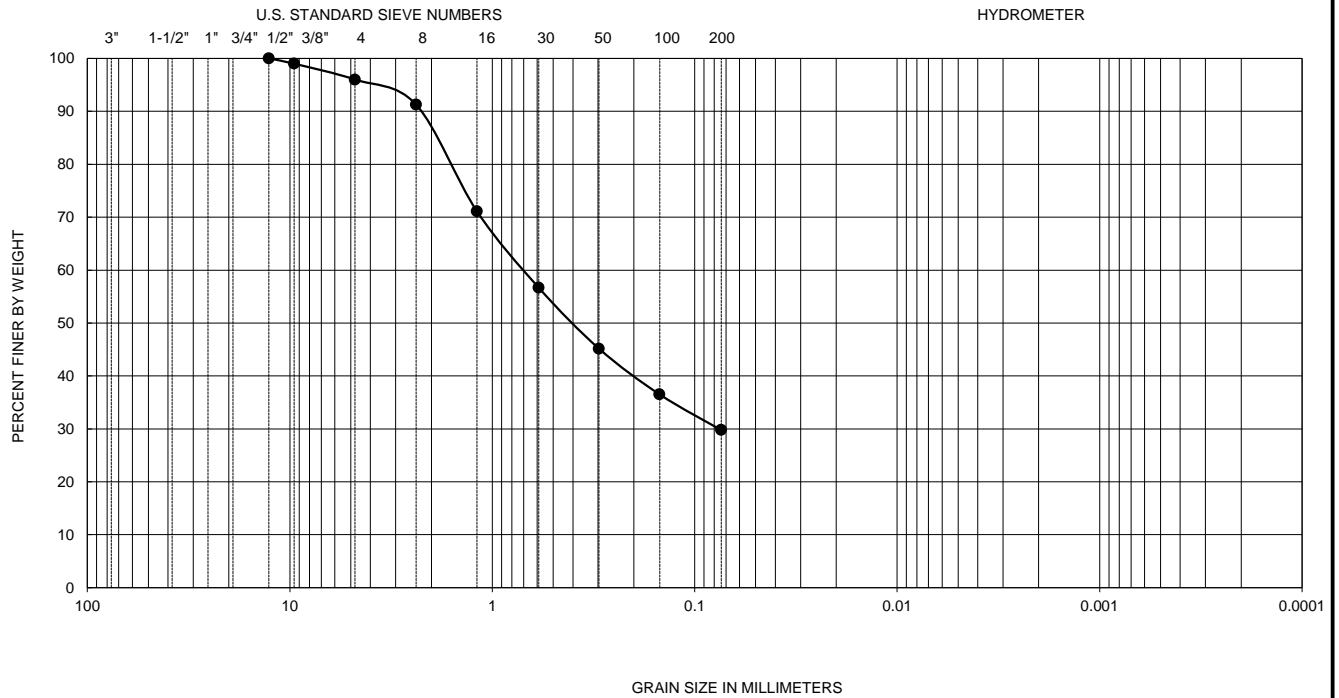
Ninyo & Moore		GRADATION TEST RESULTS		FIGURE B-1
PROJECT NO.	DATE	FLORENCE PAVEMENT REHABILITATION		
605256001	1/18	TOWN OF FLORENCE, ARIZONA

Symbol	Hole No.	Depth (ft)	Liquid Limit	Plastic Limit	Plasticity Index	D ₁₀	D ₃₀	D ₆₀	C _u	C _c	Passing No. 200 (%)	U.S.C.S
●	B-2	0.25-2.0	24	19	5	--	--	--	--	--	30	SC-SM

PERFORMED IN GENERAL ACCORDANCE WITH ASTM D 422

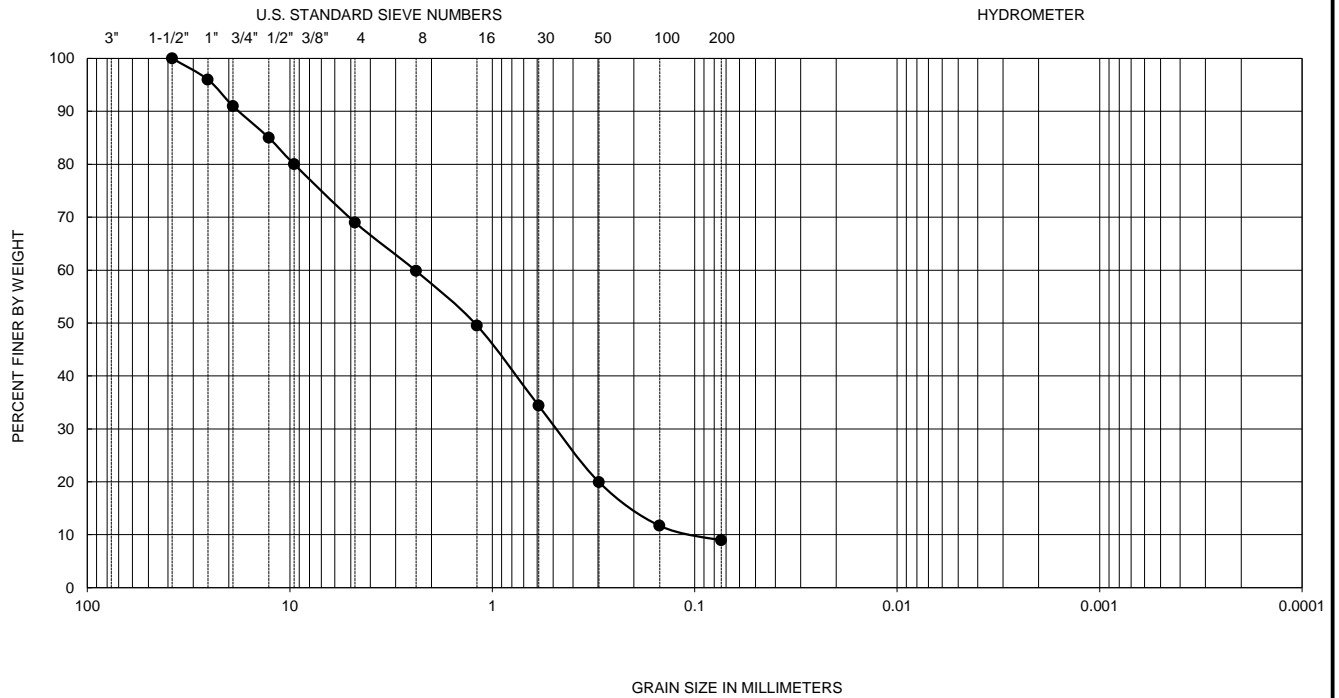
Ninyo & Moore		GRADATION TEST RESULTS		FIGURE B-2
PROJECT NO.	DATE	FLORENCE PAVEMENT REHABILITATION		
605256001	1/18	TOWN OF FLORENCE, ARIZONA

Symbol	Hole No.	Depth (ft)	Liquid Limit	Plastic Limit	Plasticity Index	D ₁₀	D ₃₀	D ₆₀	C _u	C _c	Passing No. 200 (%)	U.S.C.S
●	B-4	0.3-2.0	--	--	NP	0.10	0.48	2.30	23.0	1.0	9	SW-SM

PERFORMED IN GENERAL ACCORDANCE WITH ASTM D 422

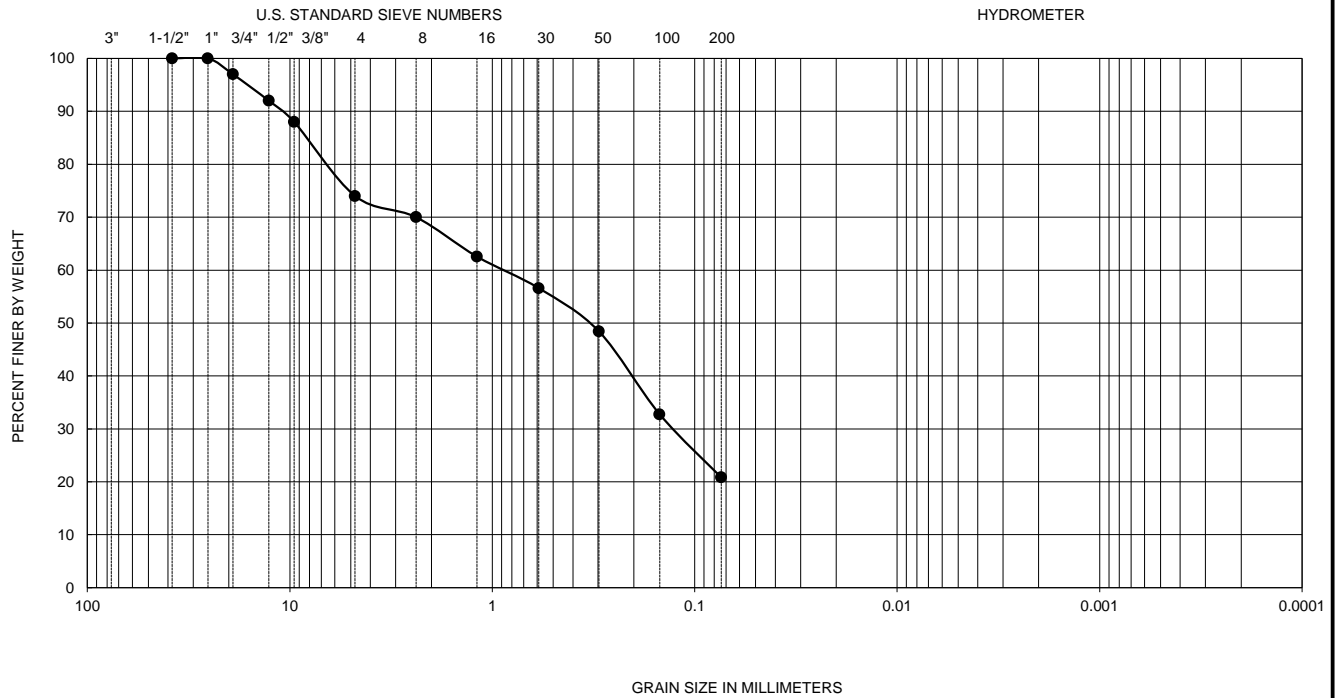
Ninyo & Moore		GRADATION TEST RESULTS		FIGURE B-3
PROJECT NO.	DATE	FLORENCE PAVEMENT REHABILITATION		
605256001	1/18	TOWN OF FLORENCE, ARIZONA

Symbol	Hole No.	Depth (ft)	Liquid Limit	Plastic Limit	Plasticity Index	D ₁₀	D ₃₀	D ₆₀	C _u	C _c	Passing No. 200 (%)	U.S.C.S
●	B-6	0.1-2.0	25	20	5	--	--	--	--	--	21	SC-SM

PERFORMED IN GENERAL ACCORDANCE WITH ASTM D 422

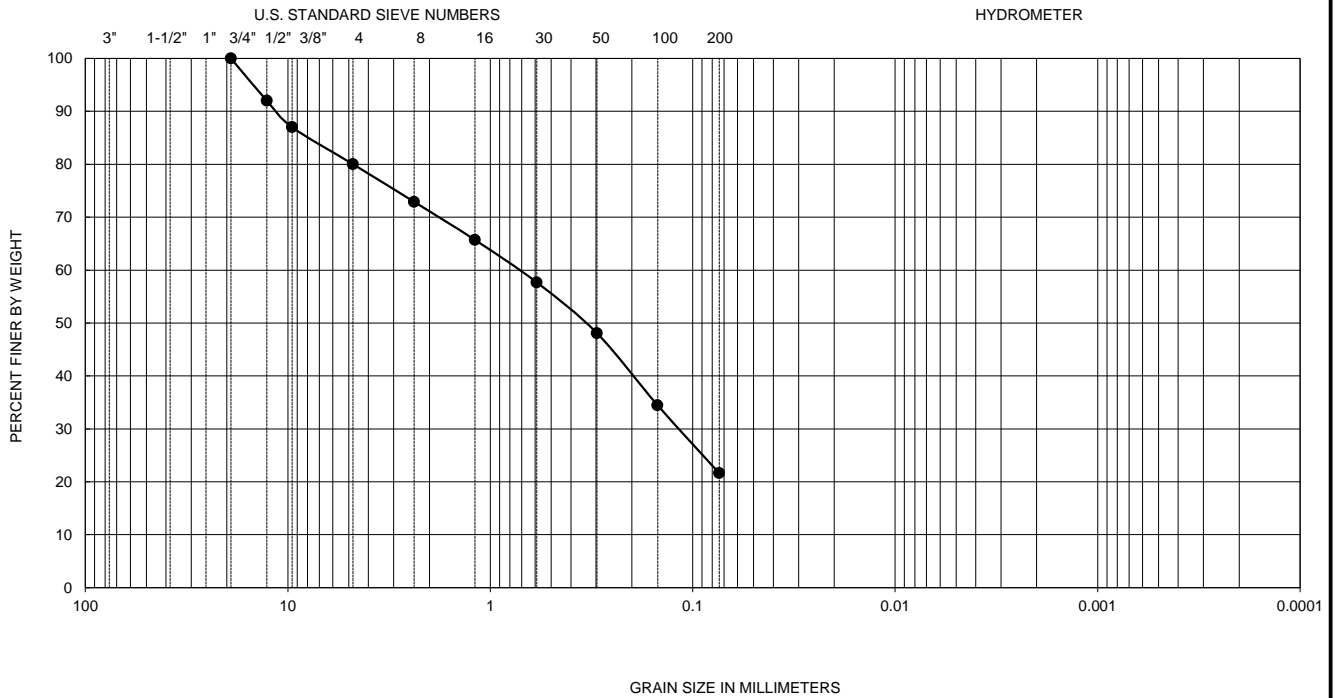
Ninyo & Moore		GRADATION TEST RESULTS		FIGURE B-4
PROJECT NO.	DATE	FLORENCE PAVEMENT REHABILITATION		
605256001	1/18	TOWN OF FLORENCE, ARIZONA

Symbol	Hole No.	Depth (ft)	Liquid Limit	Plastic Limit	Plasticity Index	D ₁₀	D ₃₀	D ₆₀	C _u	C _c	Passing No. 200 (%)	U.S.C.S
●	B-9	0.3-2.0	31	28	3	--	--	--	--	--	22	SM

PERFORMED IN GENERAL ACCORDANCE WITH ASTM D 422

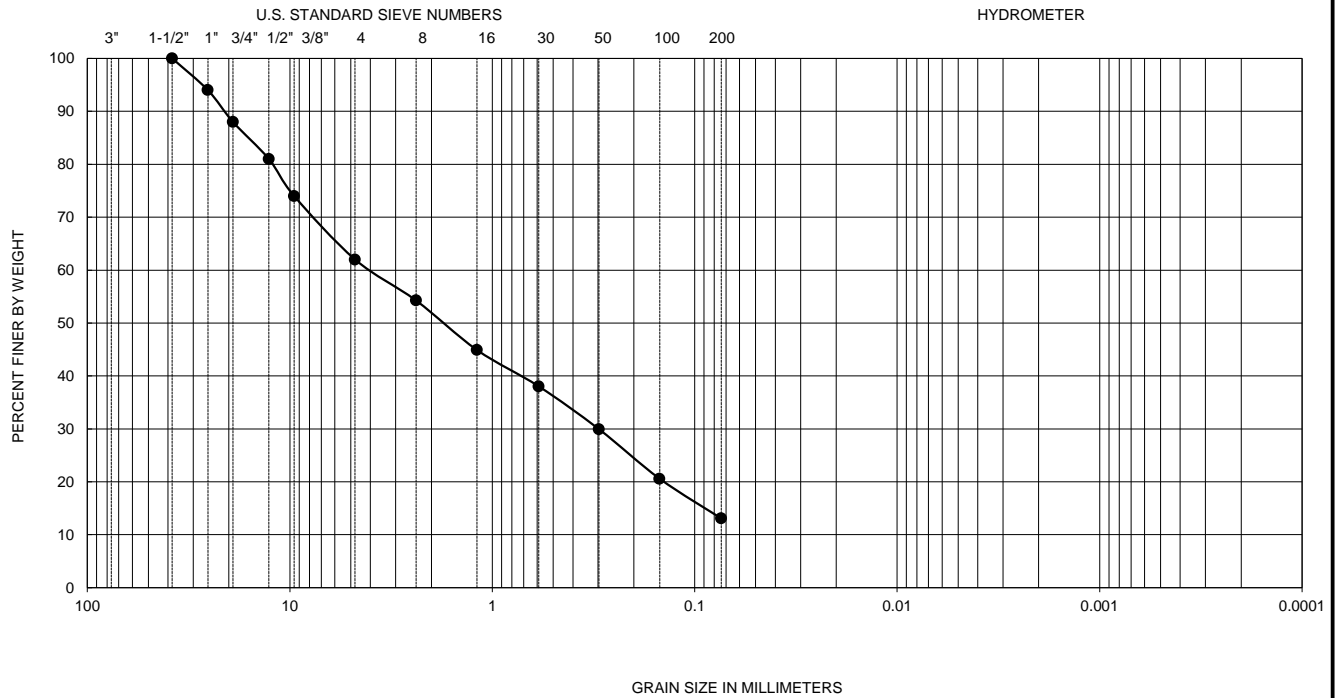
Ninyo & Moore		GRADATION TEST RESULTS	FIGURE
PROJECT NO.	DATE		
605256001	1/18	FLORENCE PAVEMENT REHABILITATION TOWN OF FLORENCE, ARIZONA	B-5

Symbol	Hole No.	Depth (ft)	Liquid Limit	Plastic Limit	Plasticity Index	D ₁₀	D ₃₀	D ₆₀	C _u	C _c	Passing No. 200 (%)	U.S.C.S
●	B-11	0.25-2.0	31	20	11	--	--	--	--	--	13	SC

PERFORMED IN GENERAL ACCORDANCE WITH ASTM D 422

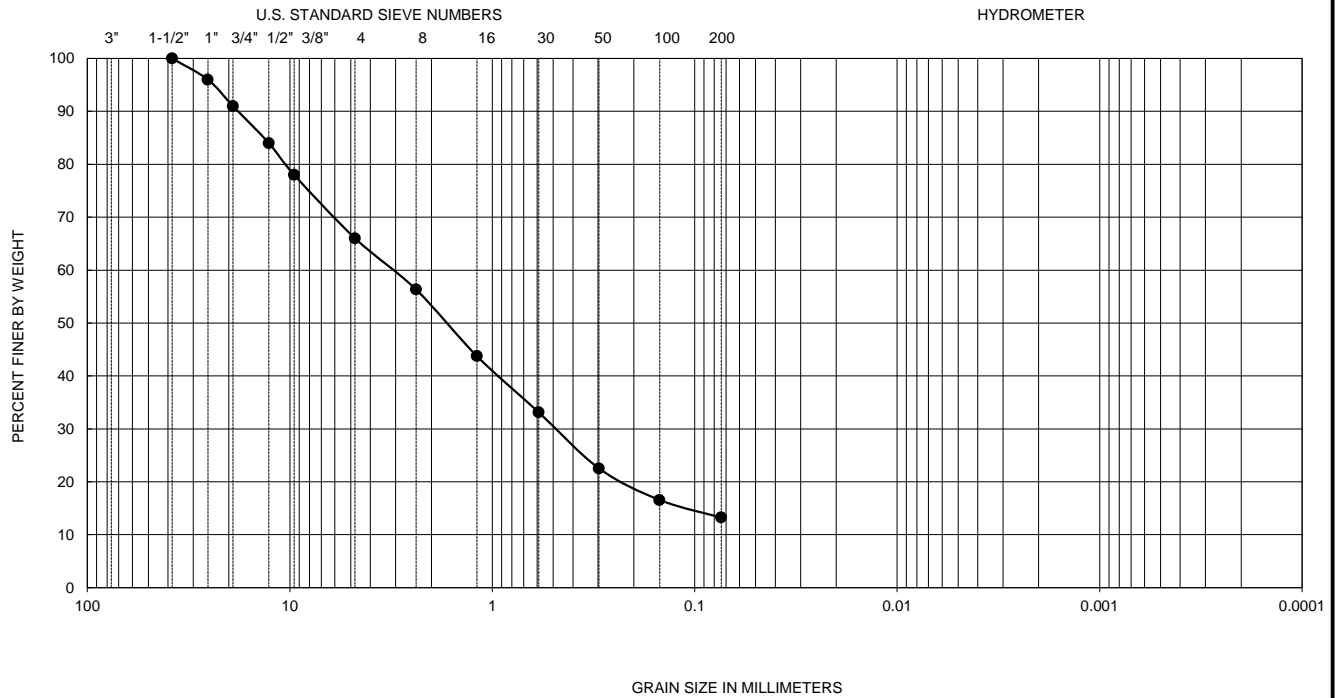
Ninyo & Moore		GRADATION TEST RESULTS		FIGURE B-6
PROJECT NO.	DATE	FLORENCE PAVEMENT REHABILITATION		
605256001	1/18	TOWN OF FLORENCE, ARIZONA

Symbol	Hole No.	Depth (ft)	Liquid Limit	Plastic Limit	Plasticity Index	D ₁₀	D ₃₀	D ₆₀	C _u	C _c	Passing No. 200 (%)	U.S.C.S
●	B-17	0.1-2.0	--	--	NP	--	--	--	--	--	13	SM

PERFORMED IN GENERAL ACCORDANCE WITH ASTM D 422

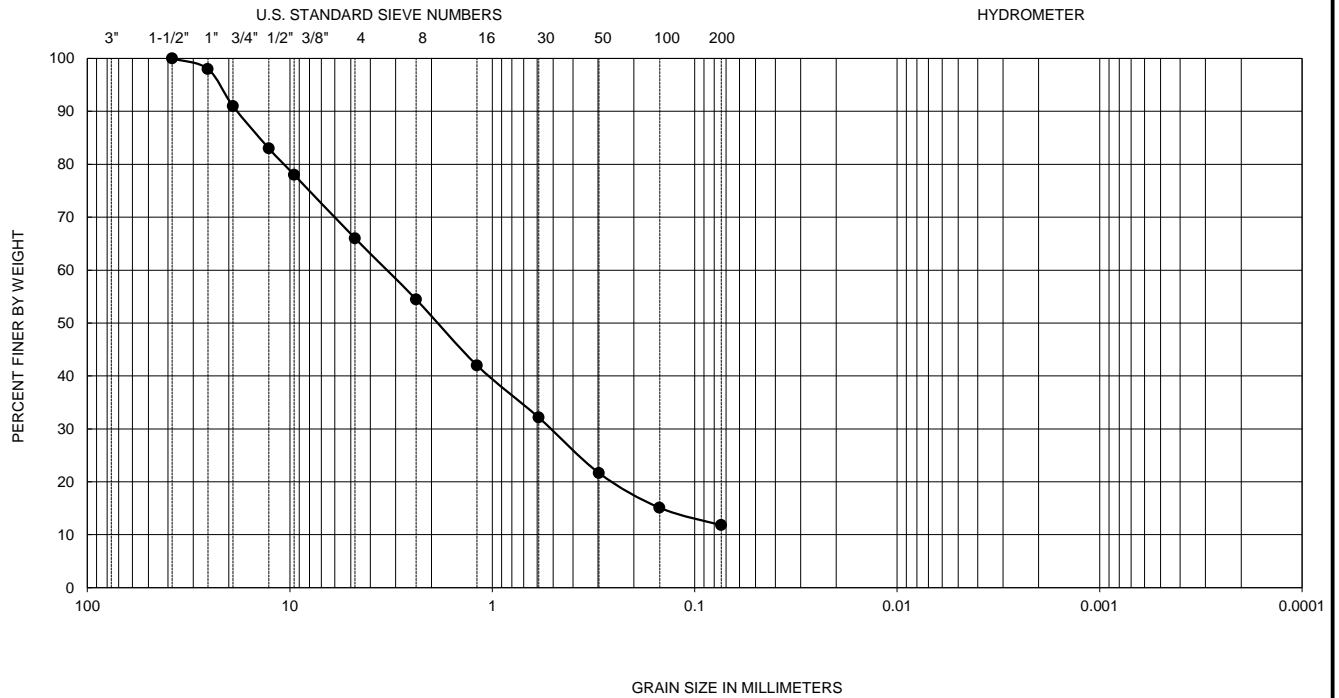
Ninyo & Moore		GRADATION TEST RESULTS		FIGURE B-7
PROJECT NO.	DATE	FLORENCE PAVEMENT REHABILITATION		
605256001	1/18	TOWN OF FLORENCE, ARIZONA

Symbol	Hole No.	Depth (ft)	Liquid Limit	Plastic Limit	Plasticity Index	D ₁₀	D ₃₀	D ₆₀	C _u	C _c	Passing No. 200 (%)	U.S.C.S
●	B-19	0.1-2.0	--	--	NP	0.07	0.50	3.20	43.2	1.1	12	SW-SM

PERFORMED IN GENERAL ACCORDANCE WITH ASTM D 422

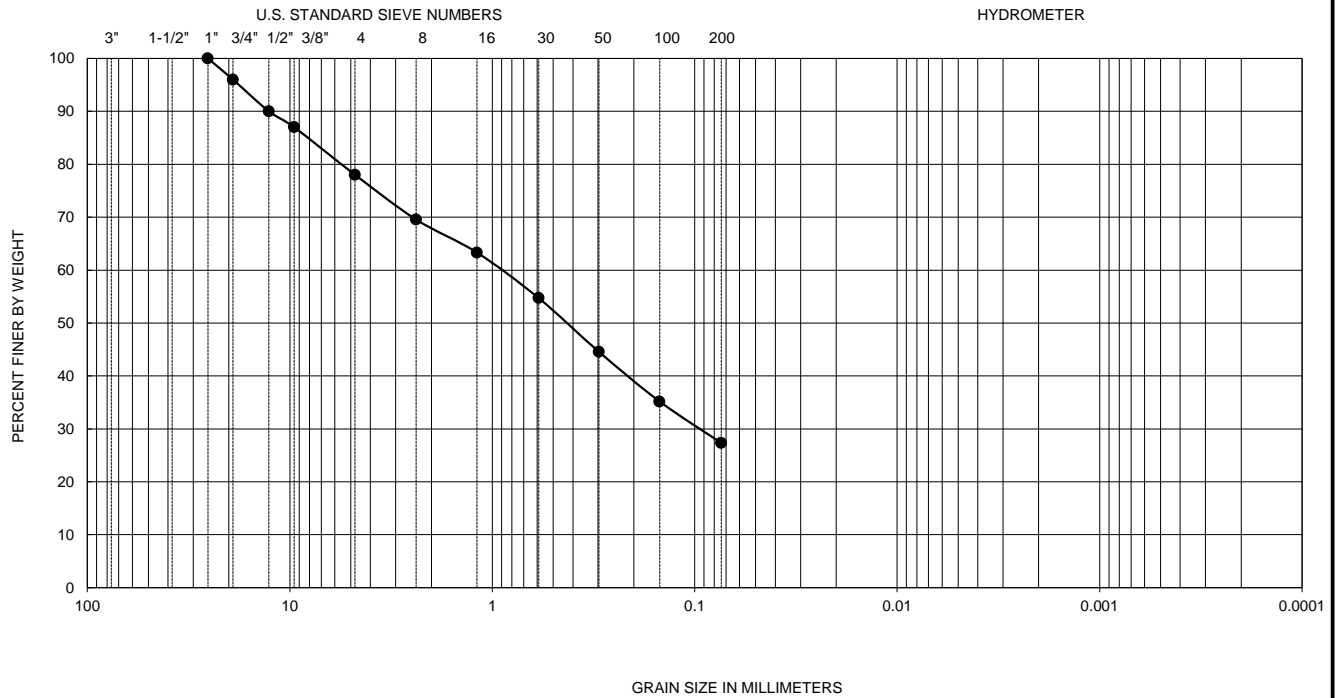
Symbol	Hole No.	Depth (ft)	Liquid Limit	Plastic Limit	Plasticity Index	D ₁₀	D ₃₀	D ₆₀	C _u	C _c	Passing No. 200 (%)	U.S.C.S
●	B-21	0.1-2.0	24	17	7	--	--	--	--	--	27	SC-SM

PERFORMED IN GENERAL ACCORDANCE WITH ASTM D 422

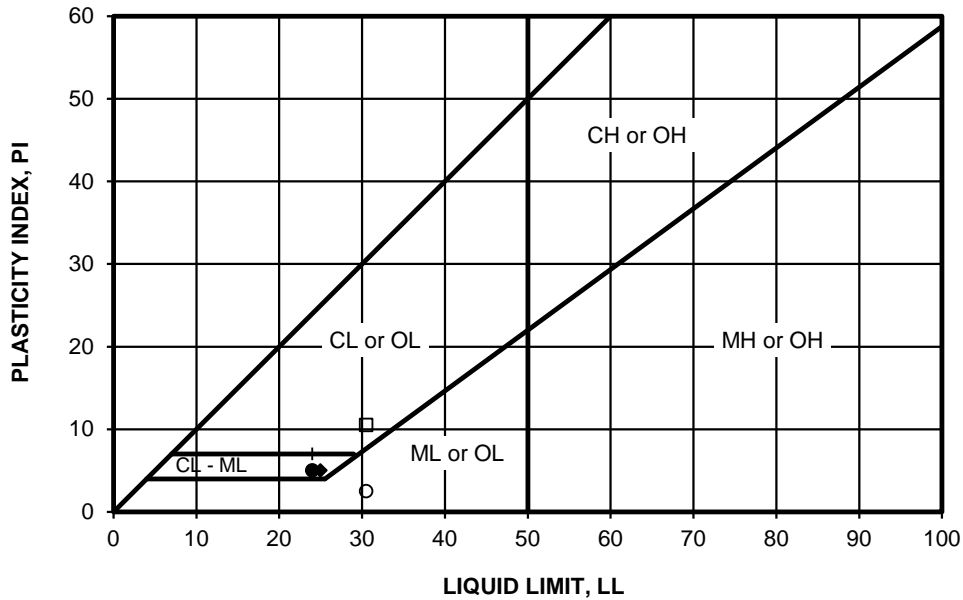
SYMBOL	LOCATION	DEPTH (FT)	LIQUID LIMIT, LL	PLASTIC LIMIT, PL	PLASTICITY INDEX, PI	USCS CLASSIFICATION (Fraction Finer Than No. 40 Sieve)	USCS (Entire Sample)
●	B-2	0.25-2.0	24	19	5	CL-ML	SC-SM
■	B-4	0.3-2.0	--	--	NP	ML	SW-SM
◆	B-6	0.1-2.0	25	20	5	CL-ML	SC-SM
○	B-9	0.3-2.0	31	28	3	ML	SM
□	B-11	0.25-2.0	31	20	11	CL	SC
△	B-17	0.1-2.0	--	--	--	ML	SM
×	B-19	0.1-2.0	--	--	NP	ML	SW-SM
+	B-21	0.1-2.0	24	17	7	CL-ML	SC-SM

NP - INDICATES NON-PLASTIC

PERFORMED IN GENERAL ACCORDANCE WITH ASTM D 4318

Tests were performed on selected representative fine-grained soil samples to evaluate the liquid limit, plastic limit, and plasticity index in general accordance with ASTM D 4318. These test results were utilized to evaluate the soil classification in accordance with the Unified Soil Classification System. The test results and classifications are shown on Figure B-9.
